Manhole Inspection Summary

Manhole # S21GG1009MH

Insp Date: **12/6/06 2:11 PM**

Location Address: **1600 W 41ST ST**

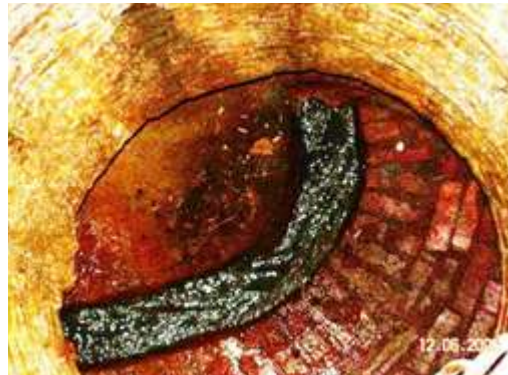
Top View

Infiltration: ☐ None ☒ **Joint** ☐ Cracks ☒ **Mortar** ☐ Roots ☐ Wall

☐ Parged ☒ **Debris** (not Condition related)

Adjustment infiltration. Bench debris.

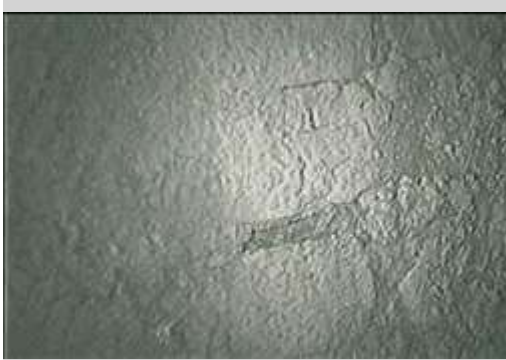
Defect

Condition: ☐ Sound ☐ Cracked ☐ Root Intrusion ☐ Loose Brick ☒ **Deteriorated**

Infiltration: ☐ None ☐ Joint ☐ Cracks ☒ **Mortar** ☐ Roots ☒ **Wall**

Barrel deterioration and infiltration.

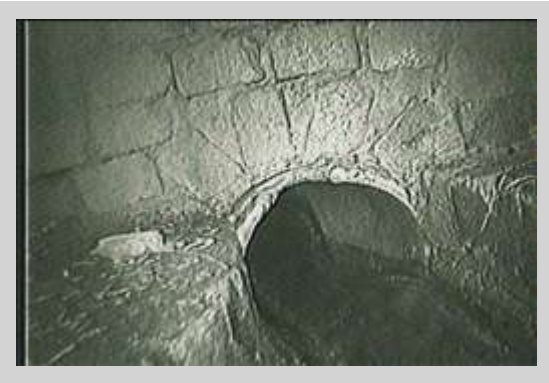
8 in. Circular Gravity Sewer Pipe Out @ 12 O'Clock

Infiltration: **Evidence** Pipe Seal Cond: **Unknown**

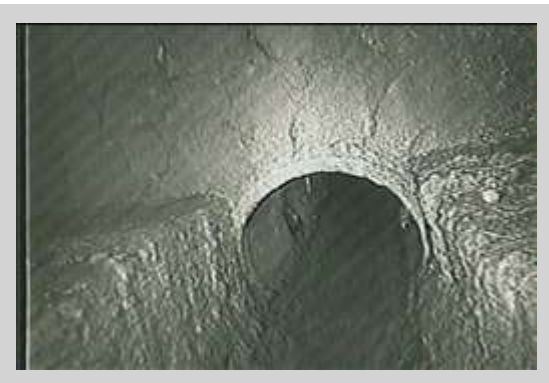
8 in. Circular Gravity Sewer Pipe In @ 8 O'Clock

Infiltration: **None** Pipe Seal Cond: **Cracked**

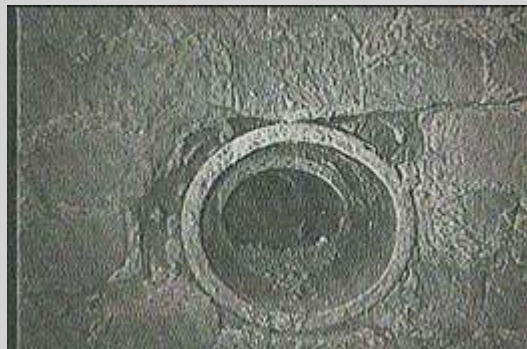
8 in. Circular Gravity Sewer

Deposits: ☐ None ☒ **Mud** ☐ Sludge ☒ **Debris** ☐ Grease

Silt Depth: **1** (in.) Deposits Extent: **Light**

Infiltration: **Evidence**

Pipe Seal Cond: **Broken**
